**PRELIMINARY SITE CHARACTERIZATION REPORT
ENCINITAS I BURN DUMP
ENCINITAS, CALIFORNIA**

18 January 2006

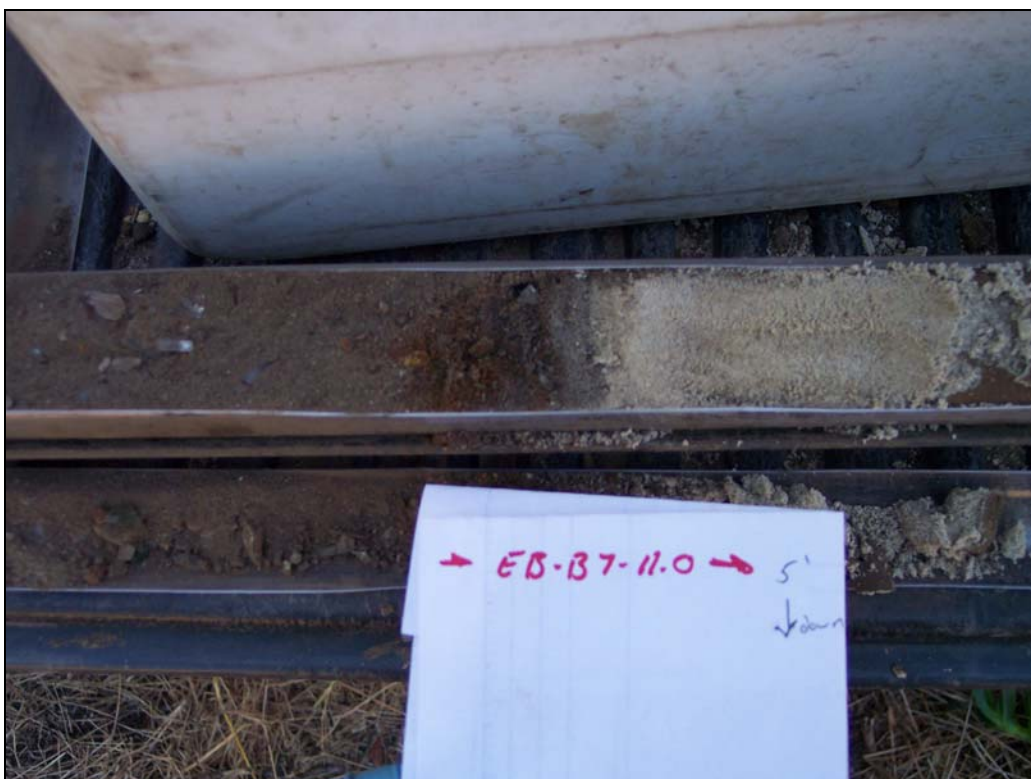
Photo 11, Contact between burn ash and native at 11.0 ft bgs at EB-B7.

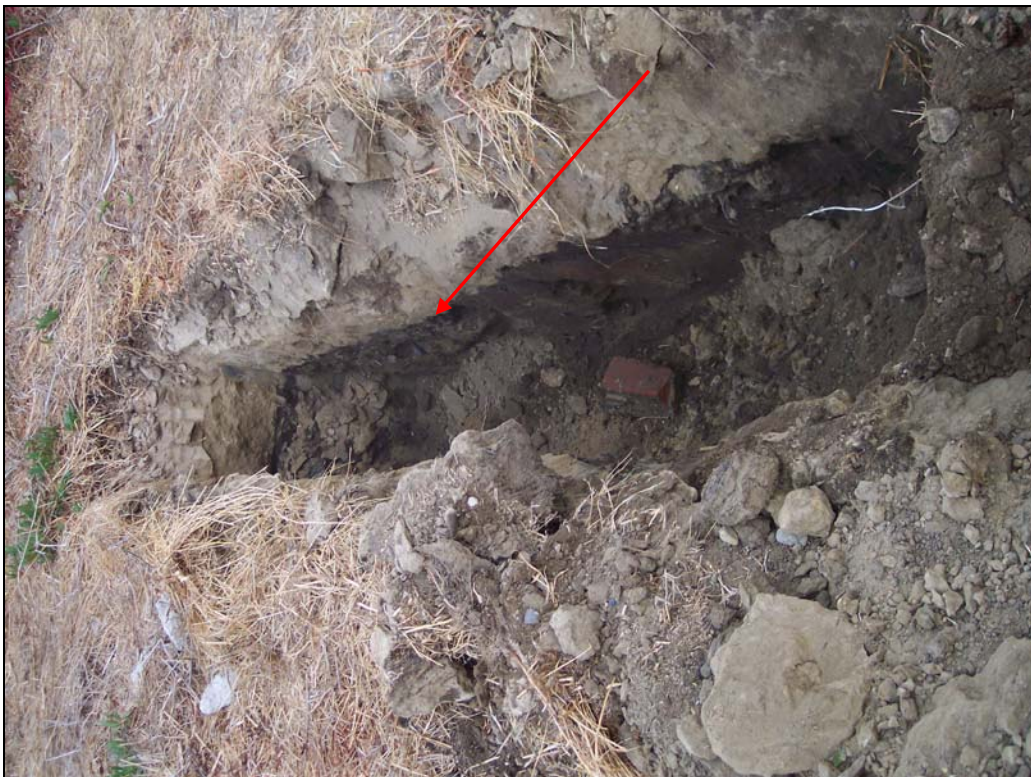
Photo 13, Approximately 2 ft bgs at EB-TP-1; Arrow points to distinct contact between cover and burn ash material; burn ash material was present to 16 ft bgs.

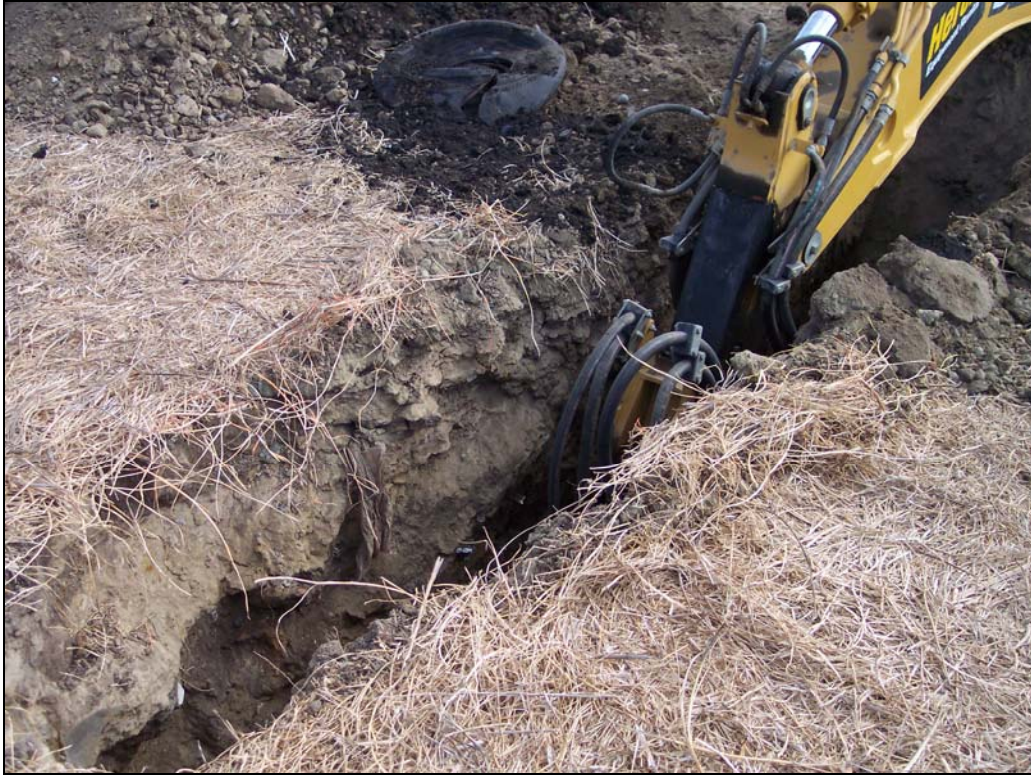
Photo 14, EB-TP-2 located north of EB-TP-1 along western edge. Burn ash material was encountered between 1.75 and 12 ft bgs. Test pits were excavated by BL Hall with a Deere 710G backhoe.

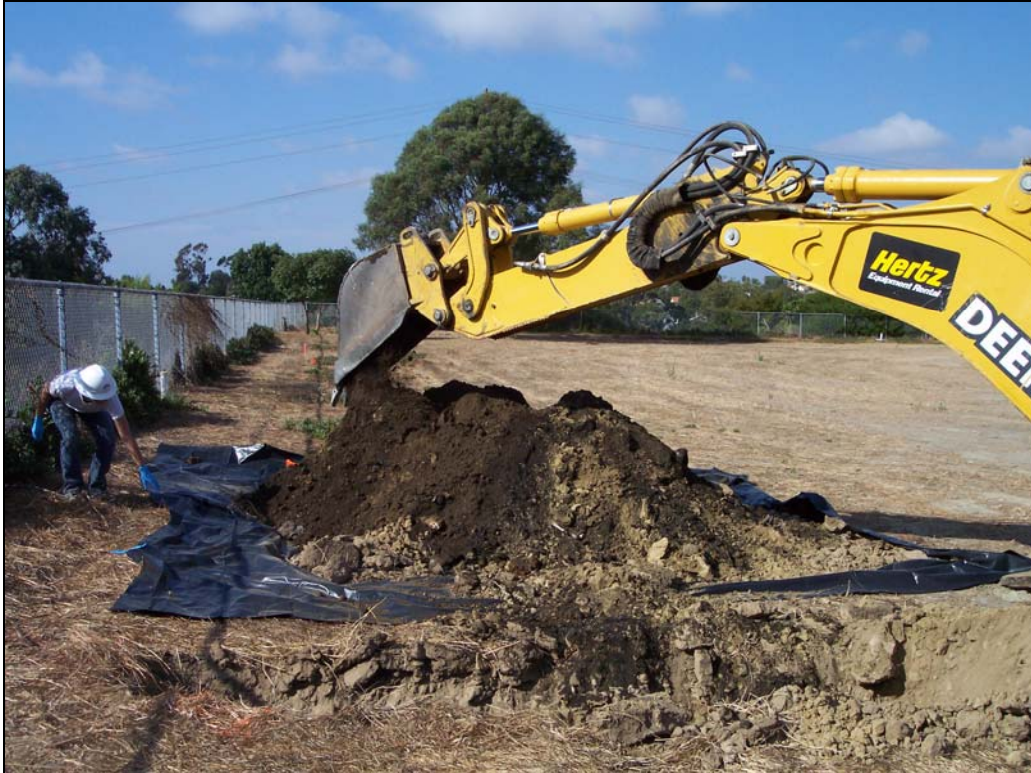
Photo 16, EB-TP-3 was located north of EB-TP-2 along western edge. Burn ash was encountered between 5 and 18 ft bgs. Soil was stockpiled on plastic sheeting to minimize contamination of surface soils with burn ash constituents.

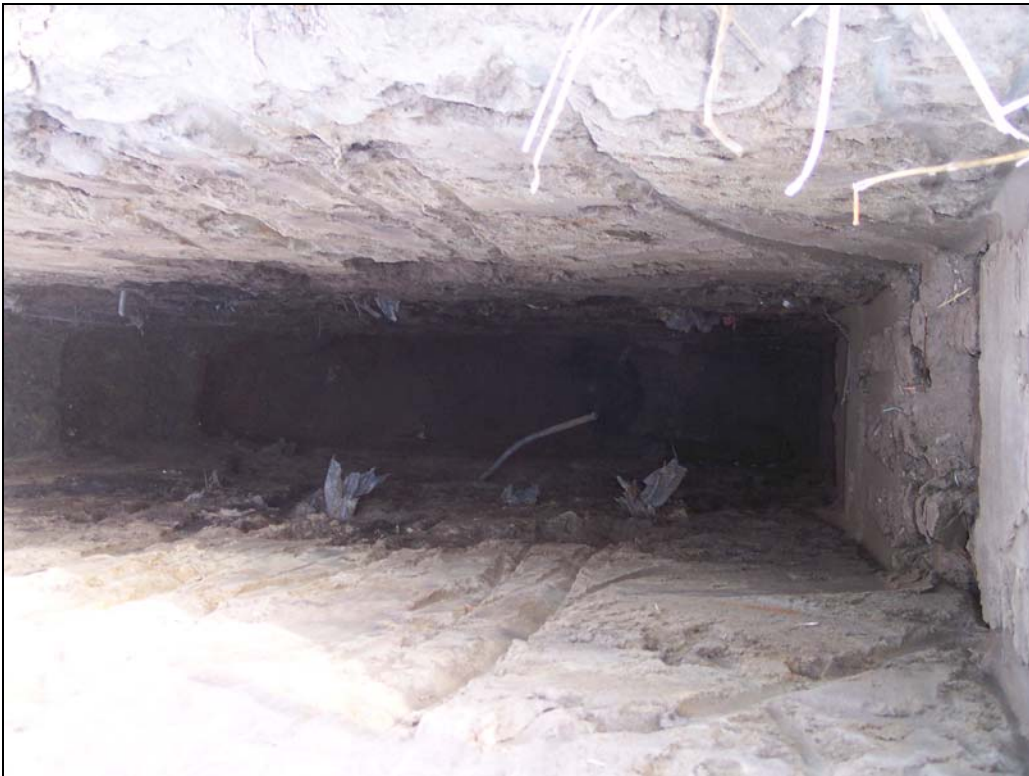
Photo 17, EB-TP-4 was located north of EB-TP-3 along the western edge. The total depth was 19 ft bgs. Burn ash materials were encountered between 3.5 and 18.5 ft bgs and are visible along walls of pit.

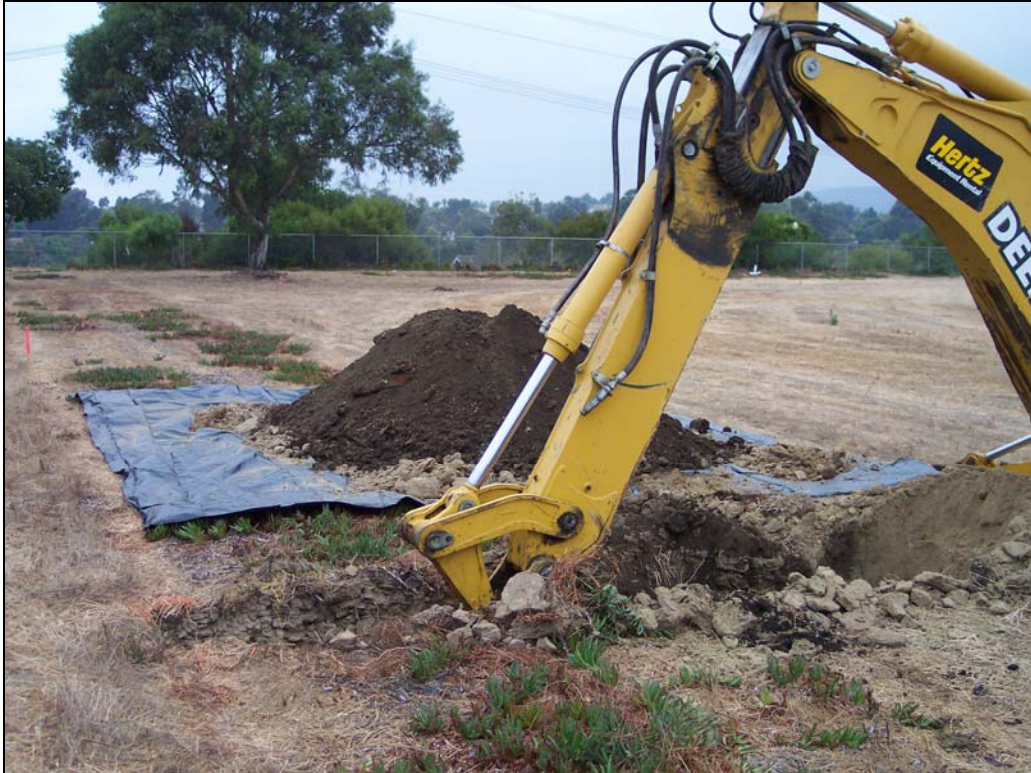
Photo 18, EB-TP-5 was located north of EB-TP-4 along western edge. Burn ash was encountered 4 ft bgs and extended to a depth of 11 ft bgs.

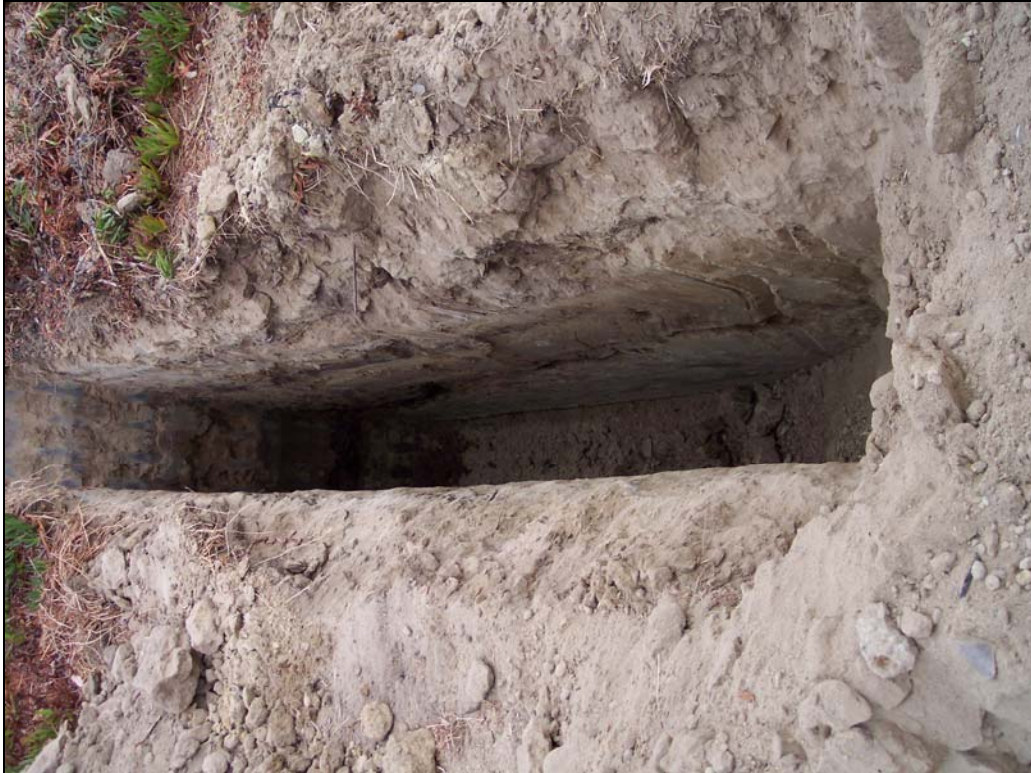
Photo 20, EB-TP-6 had a thin layer of burn ash material from 6 to 8.5 ft bgs.

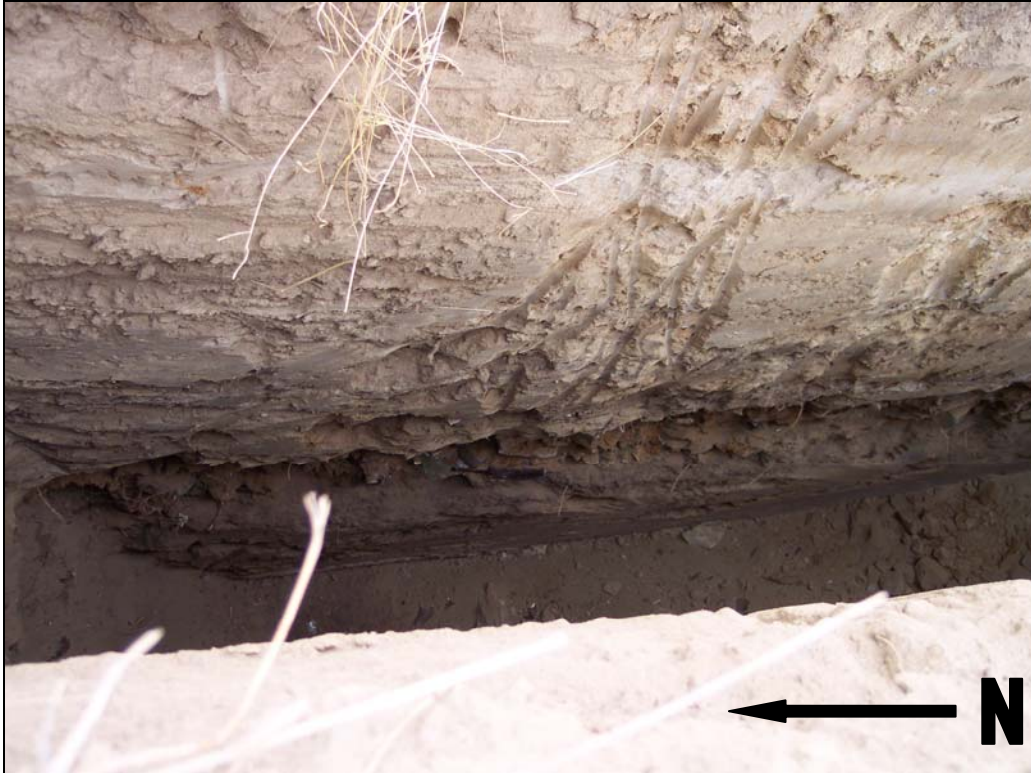
Photo 22, Waste at EB-TP-7 was encountered at 4 ft bgs on the southern side and 6 ft bgs on the northern side. Native soil was encountered at 13 ft bgs.

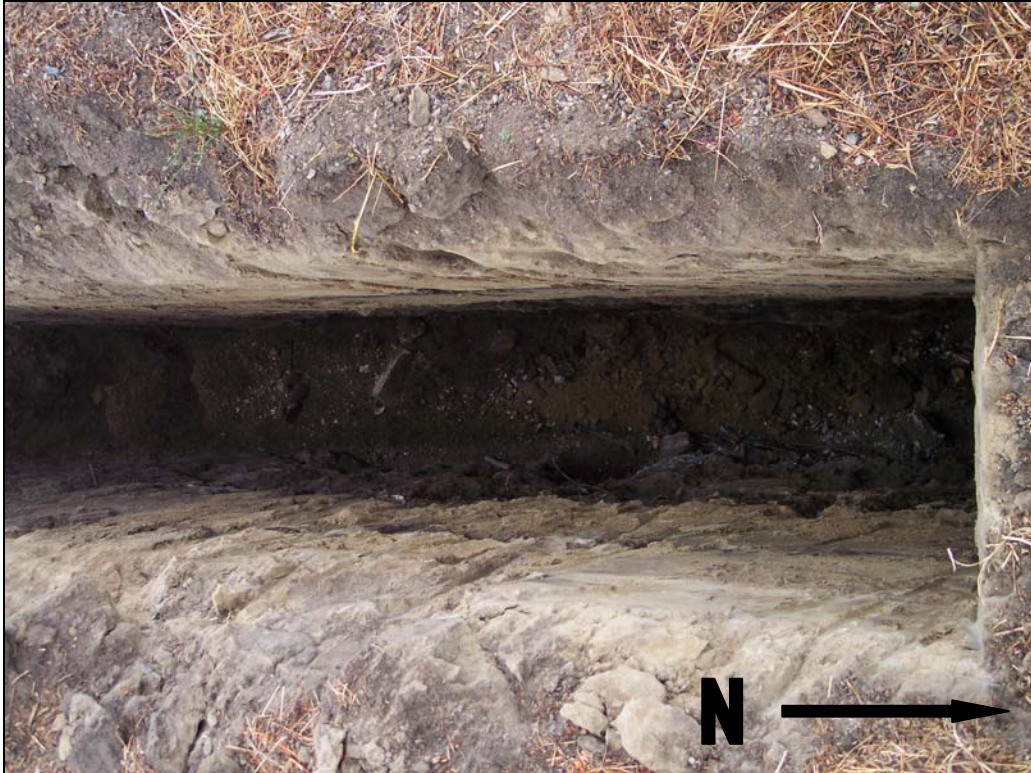
Photo 24, Waste at EB-TP-8 began at 4 ft bgs on the southern side and 6ft bgs on the northern side. Native soil was encountered at 19 ft bgs.

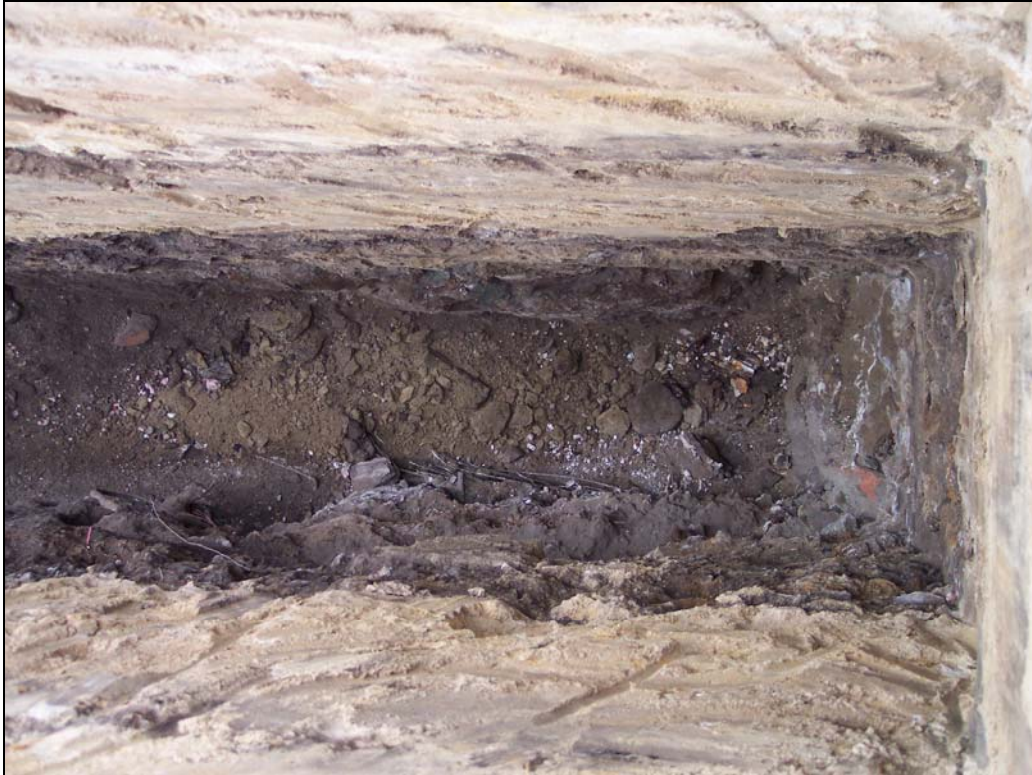
Photo 26, Waste began 3 ft bgs. EB-TP-9 was excavated to 10 ft bgs and backfilled with clean fill.

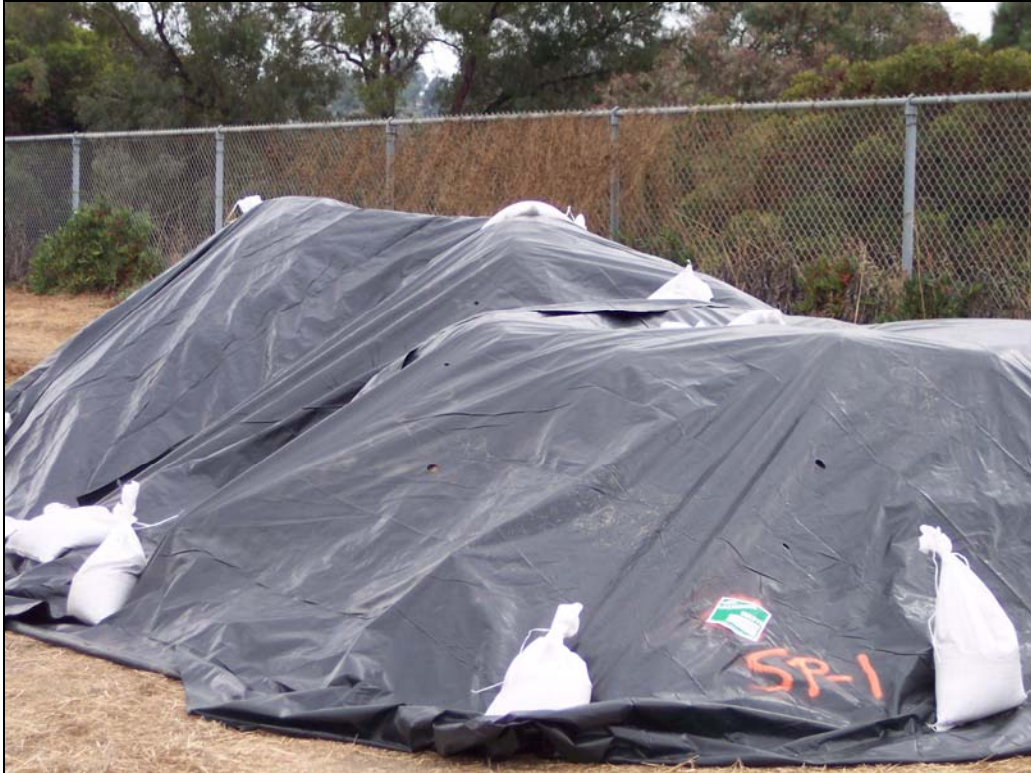
Photo 28, SP-1 consisted of excavated cover and burn ash materials from the test pits. It was stockpiled on top of and covered with plastic sheeting.

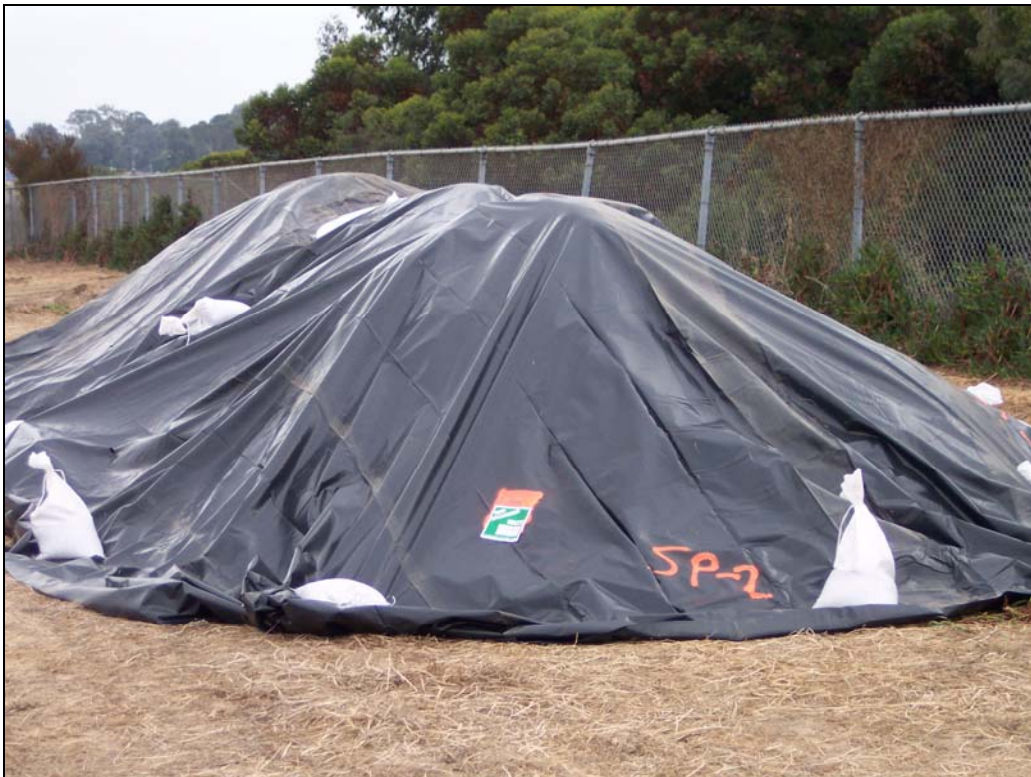
Photo 29 SP-2 consisted of cover and burn ash material. It was stockpiled on and covered with plastic sheeting.

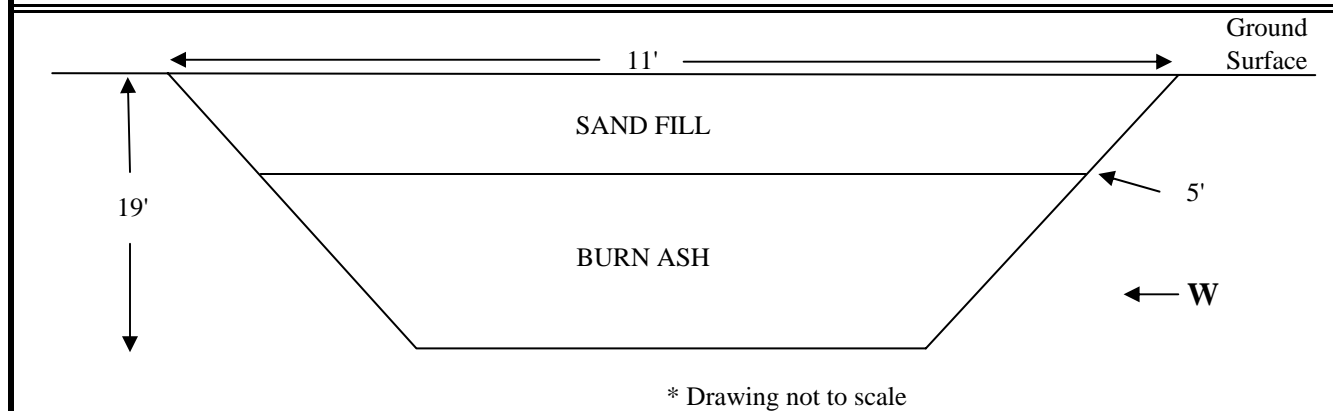
Cross Section View

Depth (ft)	Description	PID (ppm)	Sample ID/Comments
0.0	Poorly-graded sand (FILL), 10YR 6/3 pale brown, medium grained sand, dry, loose, no odor.	0.0	EB-TP3-1.0
5.0	Silty sand (BURN ASH), 10YR 2/2 very dark brown, dry, loose, glass, metal, tires, brick, light blue material with waxy-luster, plastic, and ceramic tile.	0.0	EB-TP3-6.0
18.0	Becomes mixed with poorly-graded sand (SP), 10YR 5/6 yellowish brown, moist, no odor, glass and metal fragments.		
	Backfilled with clean sand

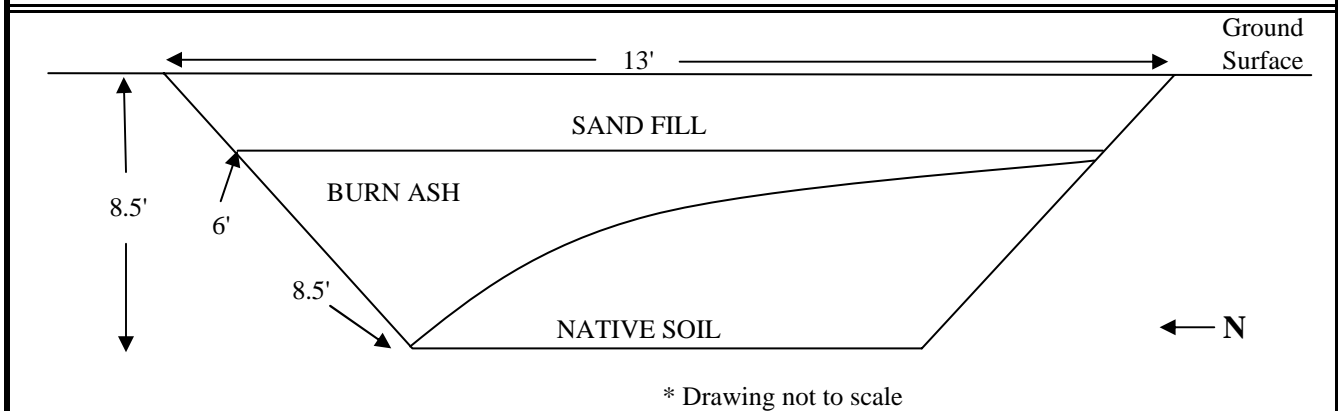
Cross Section View

Depth (ft)	Description	PID (ppm)	Sample ID/Comments
0.0	Poorly-graded sand with gravel (FILL), 10YR 6/4 light yellowish brown, dry, loose, few glass fragments, medium-grained sand.	0.0	EB-TP6-1.0
6.0	Silty sand (BURN ASH), 10YR 2/2 very dark brown, dry, loose, no odor, glass and metal fragments, layer becomes thicker to the north.	0.0	EB-TP6-6.0
8.5	Poorly-graded sand (SP), 10YR 7/3 pale yellow, moist, dense, no odor, medium- to coarse-grained sand.	0.0	EB-TP6-8.5
	Backfilled with clean sand

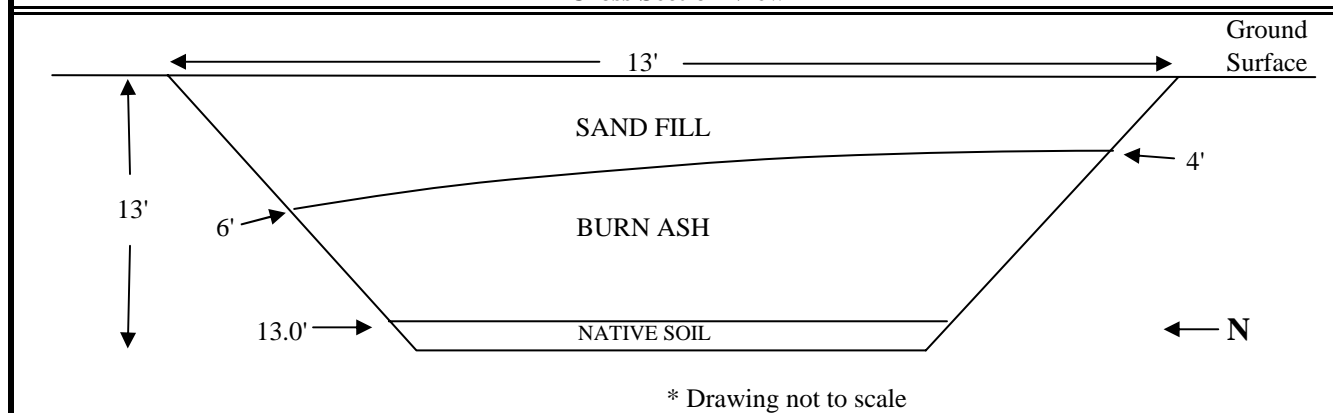
Cross Section View

Depth (ft)	Description	PID (ppm)	Sample ID/Comments
0.0	Poorly-graded gravel with sand (FILL), 10YR 6/4 light yellowish brown, dry, loose, fine-grained sand.	0.0	EB-TP7-1.0
1.5	Poorly-graded sand (BURN ASH), 10YR 6/4 light yellowish brown, moist, dense, no odor, few glass and plastic fragments, medium-grained sand, layer becomes thicker to the north.		
5.0	Poorly-graded sand, 10YR4/6 dark yellowish brown, dry, loose, burn ash fill material.	0.0	EB-TP7-6.5
13.0	Poorly-graded sand (SP), 2.5YR 7/4 pale yellow, medium-grained sand, dry, dense, no odor.	0.0	EB-TP7-13.0
	Backfilled with clean sand

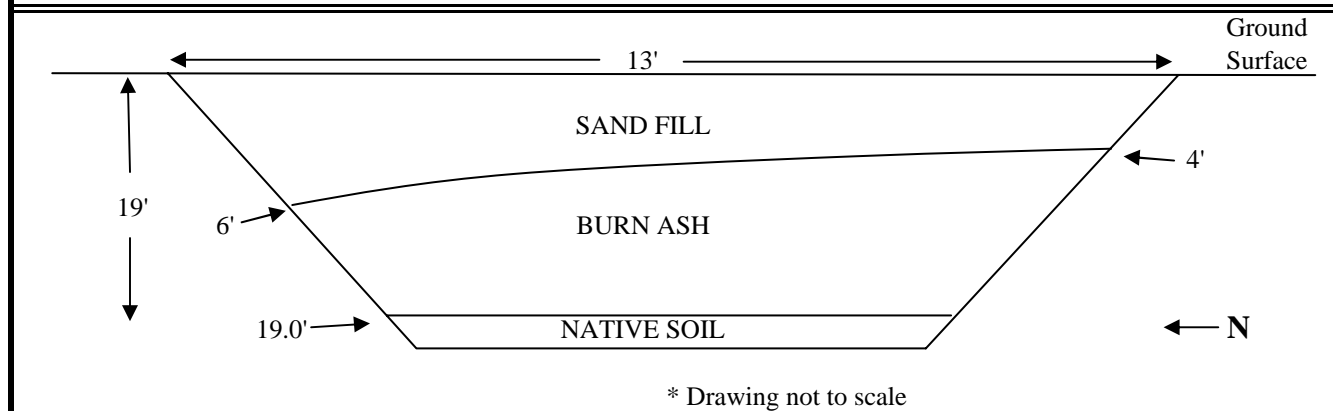
Cross Section View

Depth (ft)	Description	PID (ppm)	Sample ID/Comments
0.0	Poorly-graded sand (SP), 2.5YR 7/6 yellow, dry, loose, medium-grained sand.	0.0	EB-TP8-1.0
6.0	Silty sand (BURN ASH), 10YR 2/2 very dark brown, moist, loose, some glass, ceramics, bricks, and white chalky material.	0.0	EB-TP8-6.0
19.0	Poorly-graded sand (SP), 2.5YR 8/2 pale yellow, medium-grained sand, dry, dense.	0.0	EB-TP8-19.0
	Backfilled with clean sand

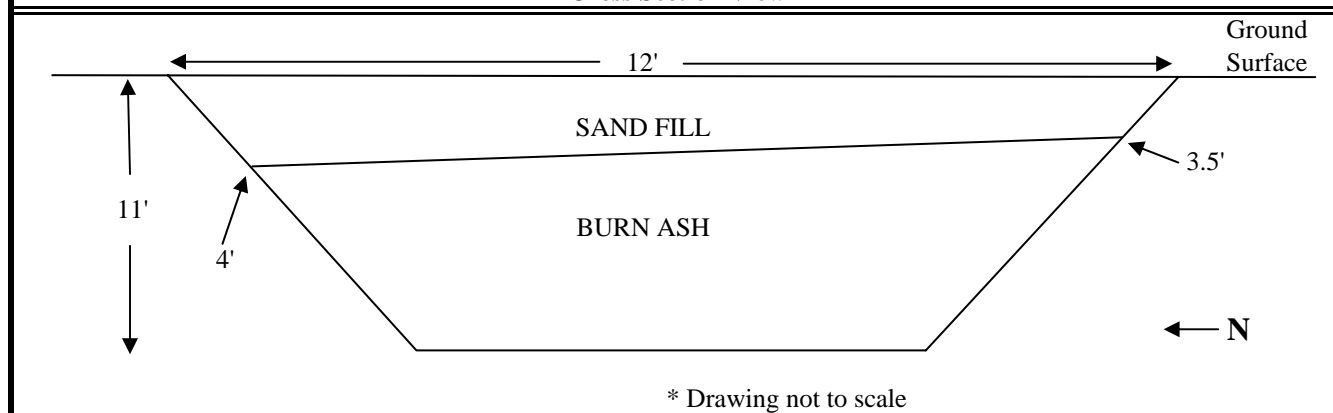
Cross Section View

Depth (ft)	Description	PID (ppm)	Sample ID/Comments
0.0	Poorly-graded sand (FILL), 2.5YR 7/6 yellow, dry, loose, medium-grained sand.	0.0	EB-TP9-1.0
3.0	Silty sand (FILL), 10YR 4/2 dark grayish brown, dry, loose, no odor, medium-grained sand.	0.0	EB-TP9-3.0
3.5-4.0	(BURN ASH) becomes 10YR 2/2 very dark brown with glass, brick, and tile fragments, burn ash fill material @ 3.5' on southern edge and 4' on northern edge.		
10.0	Lense of white building/demolition/construction material mixed with some pink, powder-like material.		
	Backfilled with clean sand
